3 TARWIN PLACE  
CRANBOURNE

## REPORT ON DOMESTIC BUILDING WORK

### Building Inspection Report

| Site address: | 3 Tarwin PLace, Cranbourne. | |

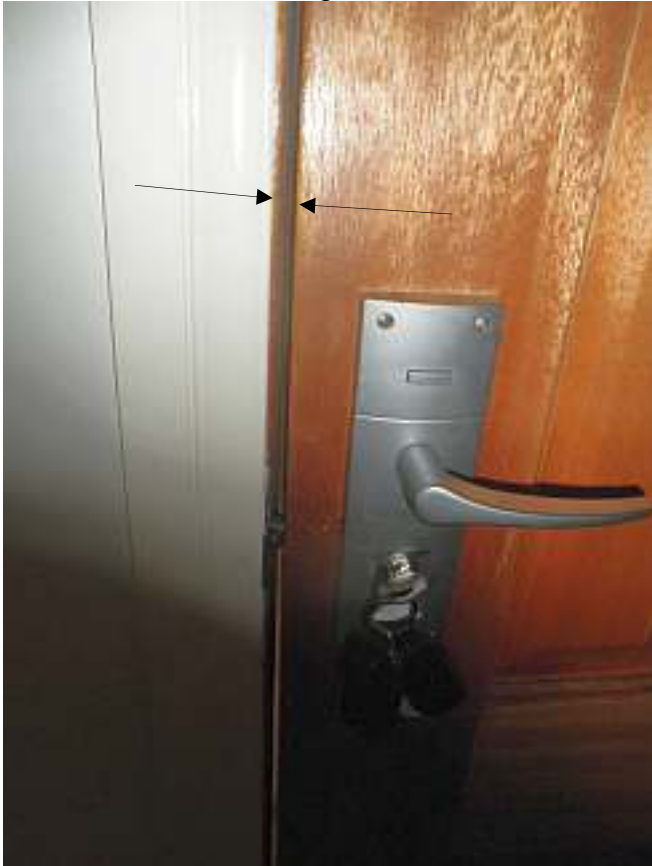
1

**Defects;** Door weather-strip is not sealing to door sill.  
>5 mm gap between door and door jamb. *Refer Guide to standards & tolerances item 8.04.*  
Door stops grooved but no seals fitted.  
Rough finish to door/window frame and door.

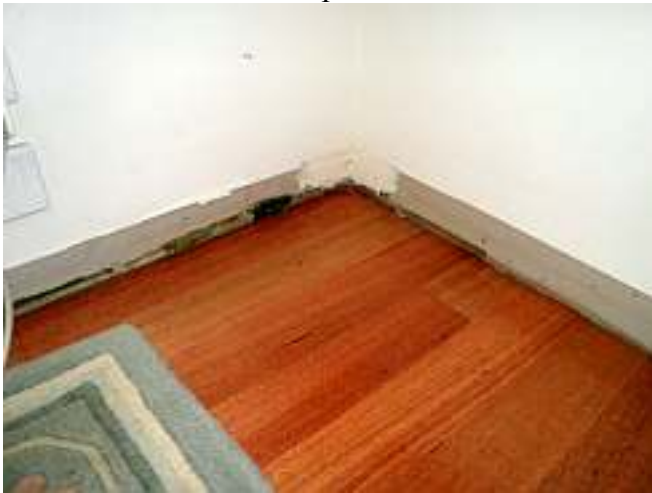
6

**Defect;** Skirting boards not replaced after repair.

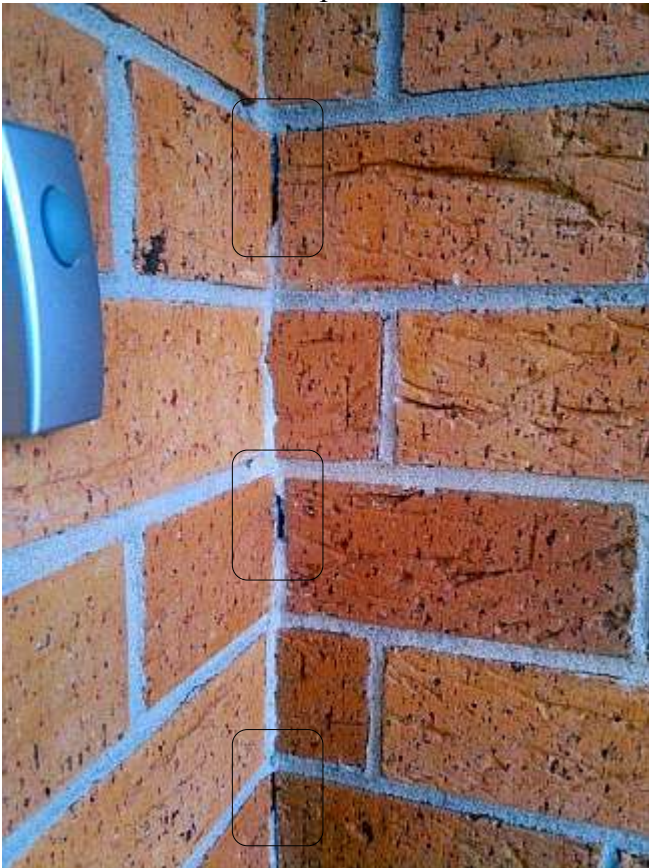
11

**Defect;** Holes in perpend to internal corner.

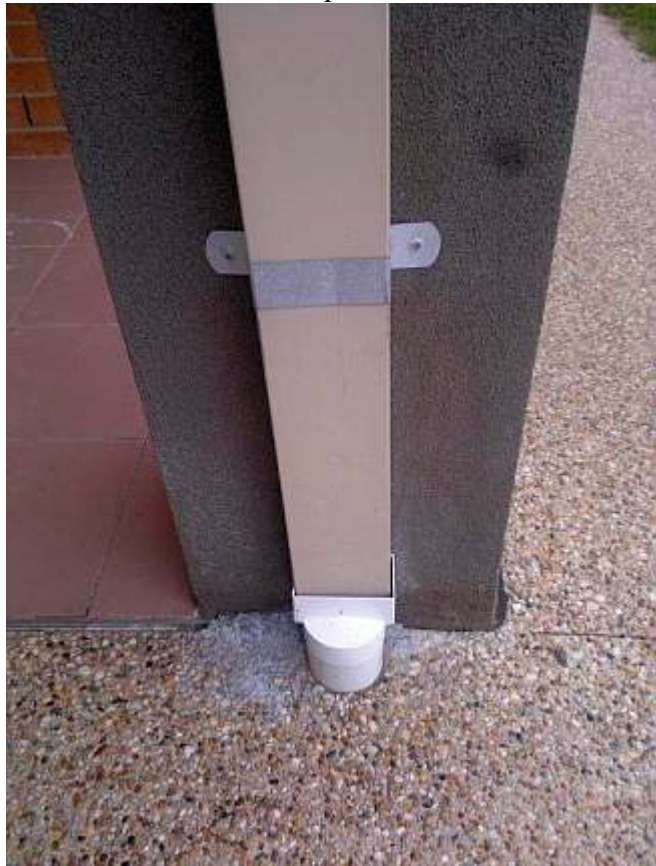
12

**Defect;** Cream coloured downpipe does not match dark coloured render.  
Galvanized downpipe clips not painted.

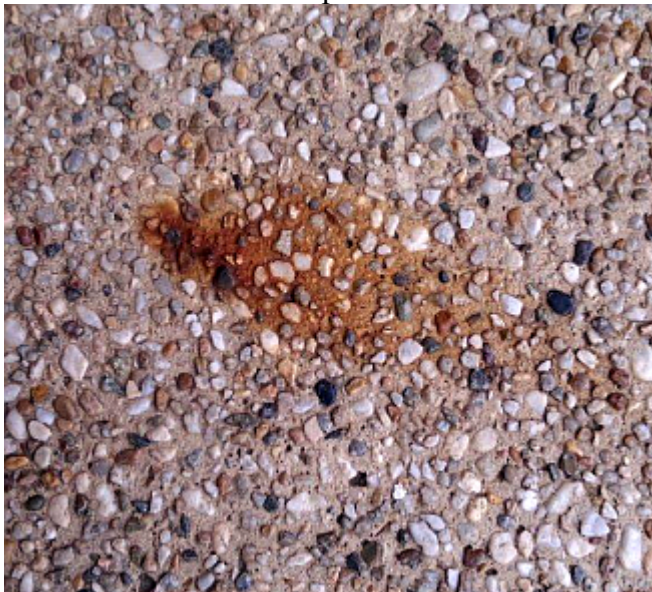
14

**Defect;** Rust marks and cracks in paving.

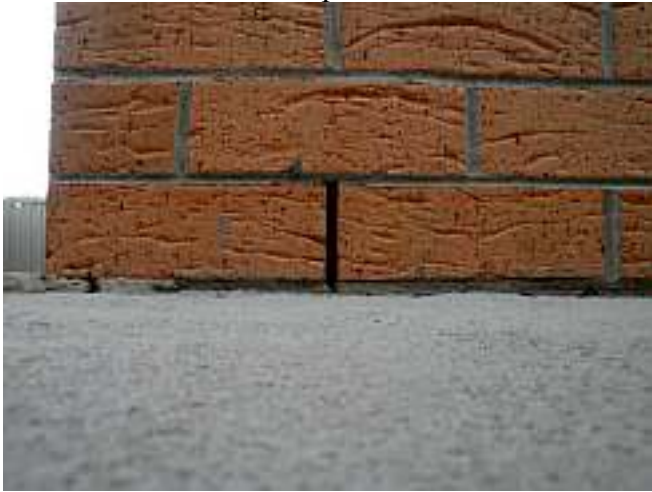
15

**WEEPHOLES****Defect;** Weepholes are < 50 mm above the paving.
